**Flood Control Project Maintenance
Levee Inspections**
LMA District Cover Sheet
Spring 2019 Levee Inspection Results

Reclamation District No. 2092 Dos Rios

Spring 2019 Levee Inspection Results

| Waterway | | | Bank | Unit Miles |
|--|---|---|---|---|
| Unit No. 01 San Joaquin River | | | Right | 3.71 |

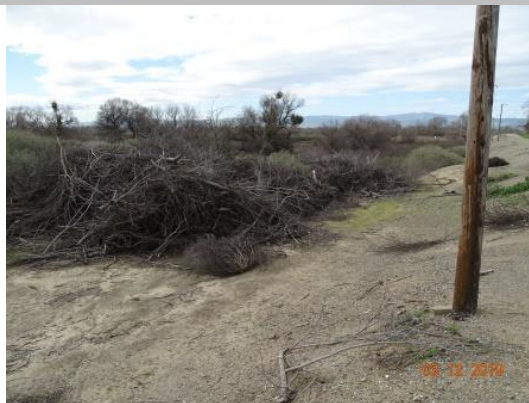
Photo 1 of 1 : SP_2019_RD2092_116_15_20190313_00057.jpg

Large pruning pile along levee slope and toe. (Spring 2019)

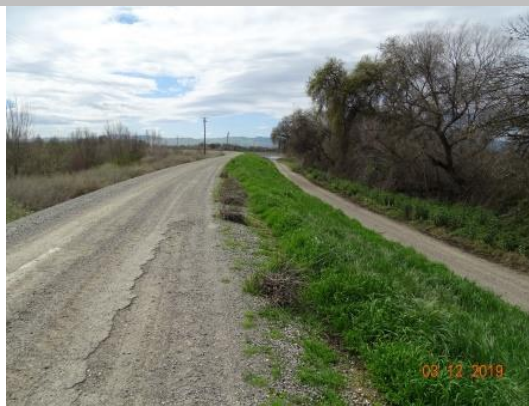
Photo 1 of 1 : SP_2019_RD2092_116_29_20190313_00059.jpg

Moderate grassy vegetation along waterside slope. (Spring 2019)

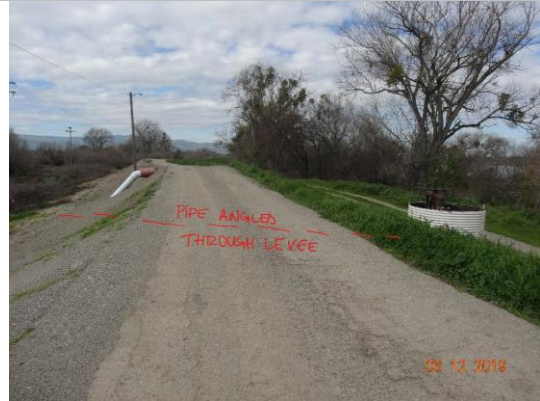
Photo 1 of 3 : UCIP_SP_2019_53799_79055.jpg

| FS_ID:53799 DS_ID:20561 EP_NO: N/A Repair Type: Urgent Crossing Status: Found UCIP Comments: 03/12/2019 A thorough internal evaluation of this crossing is necessary. Pipe shows evidence of pipe integrity (LS) issues (pipe wall sections missing on LS inlet) and levee integrity issues (sink hole visible along LS pipe alignment). Internal inspection is recommended for this crossing to determine the extent of pipe damage through the levee. Pipe crosses the levee at an angle at a depth of about 19 feet. Recommend caution be taken at this crossing when driving over levee until additional information becomes available to determine condition of pipe through levee. Recommend cover be placed on riser to address safety concern (riser is 80 inches in diameter and about 19 feet deep). Slide gate appears to be blocked by sediment/debris preventing slide gate to work properly. Unable to confirm if the flap gate located on the WS is still broken (see photo from 2017). (O. Magana - DWR UCIP)09/24/2013 Pipe rusted through at headwall on LS toe. Good candidate for video inspection. (W. Wylie - DWR UCIP) FIELD_STRUCT_DESC: 60-inch corrugated metal drainage pipe through the levee, 19 feet below the crown. Flap gate on the waterside (WS) end. Slide gate in an 80-inch corrugated metal pipe (CMP) riser on the WS slope. Concrete U-shaped headwalls on both ends. [Additional Reference(s): DWR Levee Log, 2005. USACE San Joaquin O&M Manual 5, August 1961, (HLM 0.18)]. FS Date: 3/12/2019 12:05:00 PM | | | | | | |

Overview of levee with approximate pipe alignment (pipe angled through levee).

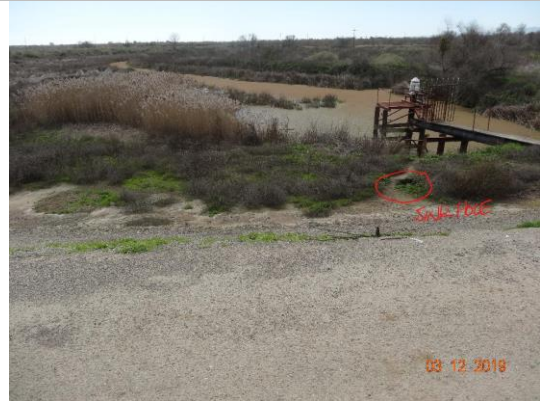
Photo 2 of 3 : UCIP_SP_2019_53799_79054.jpg

| FS_ID:53799 DS_ID:20561 EP_NO: N/A Repair Type: Urgent Crossing Status: Found UCIP Comments: 03/12/2019 A thorough internal evaluation of this crossing is necessary. Pipe shows evidence of pipe integrity (LS) issues (pipe wall sections missing on LS inlet) and levee integrity issues (sink hole visible along LS pipe alignment). Internal inspection is recommended for this crossing to determine the extent of pipe damage through the levee. Pipe crosses the levee at an angle at a depth of about 19 feet. Recommend caution be taken at this crossing when driving over levee until additional information becomes available to determine condition of pipe through levee. Recommend cover be placed on riser to address safety concern (riser is 80 inches in diameter and about 19 feet deep). Slide gate appears to be blocked by sediment/debris preventing slide gate to work properly. Unable to confirm if the flap gate located on the WS is still broken (see photo from 2017). (O. Magana - DWR UCIP)09/24/2013 Pipe rusted through at headwall on LS toe. Good candidate for video inspection. (W. Wylie - DWR UCIP) FIELD_STRUCT_DESC: 60-inch corrugated metal drainage pipe through the levee, 19 feet below the crown. Flap gate on the waterside (WS) end. Slide gate in an 80-inch corrugated metal pipe (CMP) riser on the WS slope. Concrete U-shaped headwalls on both ends. [Additional Reference(s): DWR Levee Log, 2005. USACE San Joaquin O&M Manual 5, August 1961, (HLM 0.18)]. FS Date: 3/12/2019 12:05:00 PM | | | | | | |

LS view: overview of LS with sink hole visible along pipe alignment.

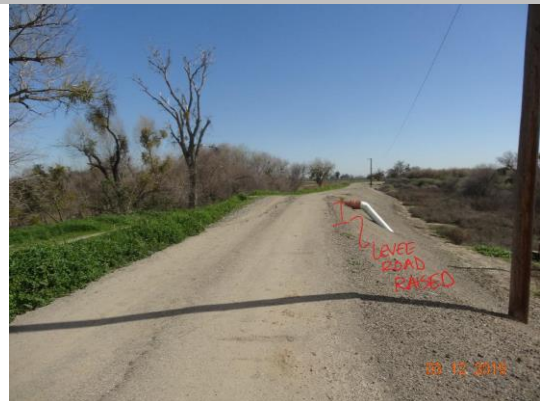
Photo 2 of 3 : UCIP_SP_2019_53815_79067.jpg

| FS_ID:53815 DS_ID:20581 EP_NO: 6254A Repair Type: Non-Urgent Crossing Status: Found UCIP Comments: 03/12/2019 Pipe has been altered on both WS and LS. A PVC pipe has been sleeved through an existing 22-inch pipe, no records have been found approving modification. This crossing appears abandoned, power source and power meter have been disconnected. Need to coordinate with CVFPB and owner. Crossing should be removed/abandoned properly per Title 23. (O. Magana - DWR UCIP) FIELD_STRUCT_DESC: *ABANDONED* 22-inch steel drainage pipe through the levee, 0.5 feet below the crown. 18-inch polyvinyl chloride (PVC) pipe sleeved through the 22-inch steel pipe. 6-inch pad constructed over the pipes. This pumping plant was constructed in 1969 during emergency conditions without a permit. Replaced a 20-inch pipe at the same location. [Additional Reference(s): DWR Levee Log, 2005]. FS Date: 3/12/2019 12:05:00 PM | | | | | |

Crown view: levee section raised at pipe crossing.

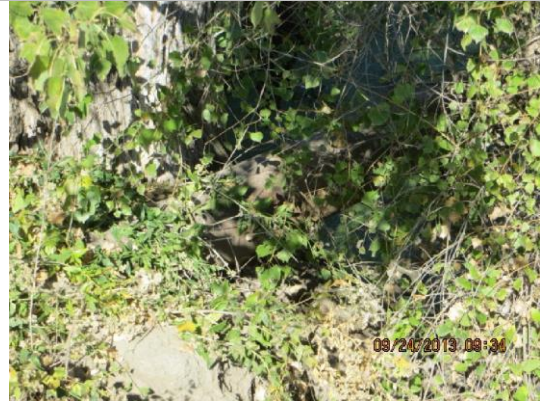
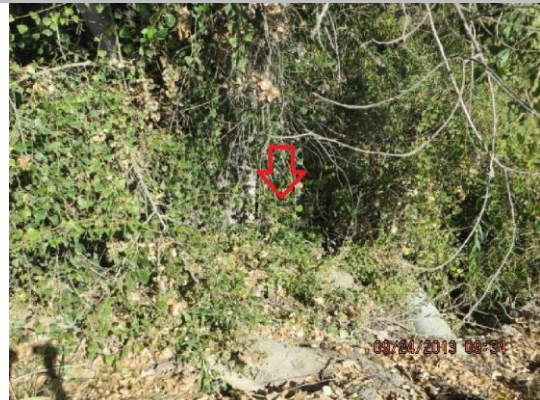
| FS_ID:53830 DS_ID:20579 EP_NO: 6254 Repair Type: Non-Urgent Crossing Status: Not Found UCIP Comments: 03/12/2019 Need to confirm fate of crossing through levee section. Levee logs indicate 14-inch pipe was removed in 2003 however, no documentation detailing extent of removal is available. Potential evidence of pipe recorded by UCIP Inspector W. Wylie in 2013. Unable to access WS toe due to high water, recommend inspecting crossing in early fall. (O. Magana - DWR UCIP) 09/24/2013 Verify pipe has been removed from levee. Pipe visible on WS at riverbank. (W. Wylie - DWR UCIP) FIELD_STRUCT_DESC: *ABANDONED* 16-inch steel drainage pipe over the levee with 3.5 feet of the fill on the top. Siphon breakers on the waterside (WS) shoulder. Pad constructed over pipes. This pumping plant was constructed in 1969 during emergency conditions without a permit. (20-inch pipe authorized to replace unauthorized 20-inch pipe and the removal of existing 12-inch and 14-inch pipe from levee section, work authorized under Permit No. 6254, 1968 - John and Robert Bogetti). [Additional Reference(s): DWR Levee Log, 2005]. FS Date: 3/12/2019 12:06:00 PM | | | | | |

Pipe visible at rivers edge on WS toe.

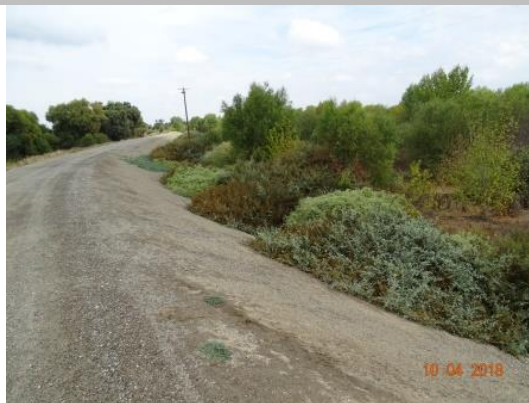
Photo 1 of 1 : SP_2019_RD2092_116_36_20190307_00021.jpg

Vegetation along landside slope and toe obstructing view. (Fall 2018)

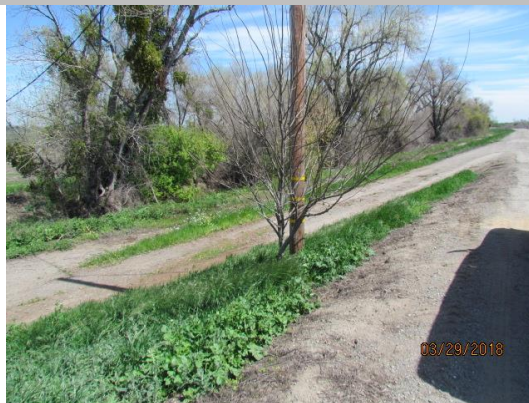
Photo 1 of 1 : SP_2019_RD2092_116_31_20190307_00014.jpg

Looking upstream at small tree on waterward should next to pole. (Spring 2018)

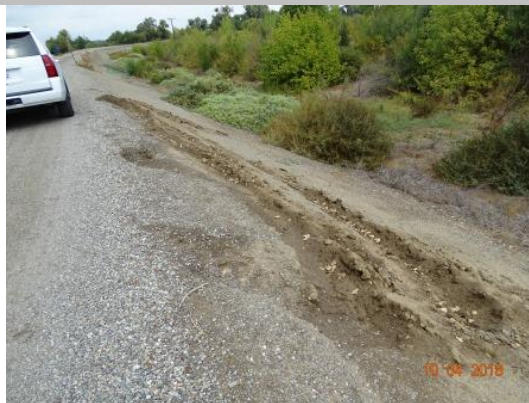
Photo 1 of 1 : SP_2019_RD2092_116_40_20190307_00024.jpg

Vehicle tracks on landside slope approximately 6" deep perpendicular to the slope. (Fall 2018)

| S3 : Repair the levee slope damaged by vehicle traffic and prevent access where possible. | | | | | |
| Vehicle tracks in landside slope should be repaired. | | | | | |

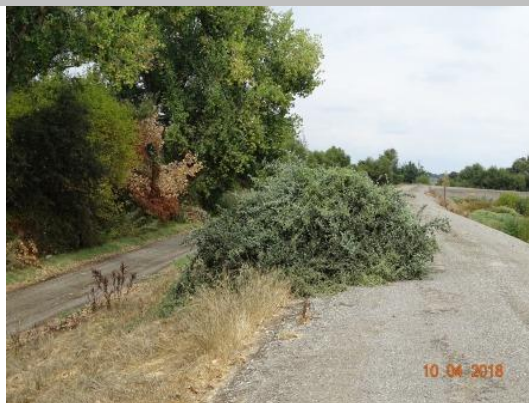
Photo 1 of 1 : SP_2019_RD2092_116_38_20190307_00022.jpg

Brush on waterside shoulder should be cleared. (Fall 2018)

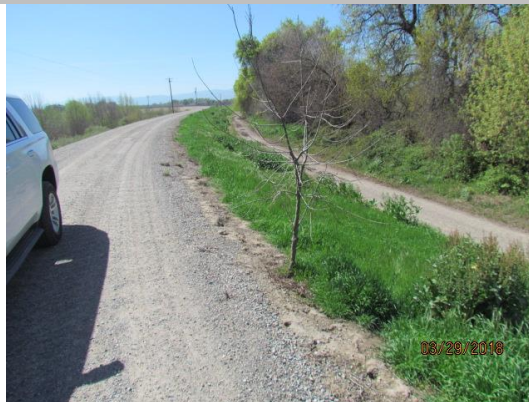
Photo 1 of 1 : SP_2019_RD2092_116_21_20190307_00011.jpg

Looking downstream at small tree on waterward slope. (Spring 2018)

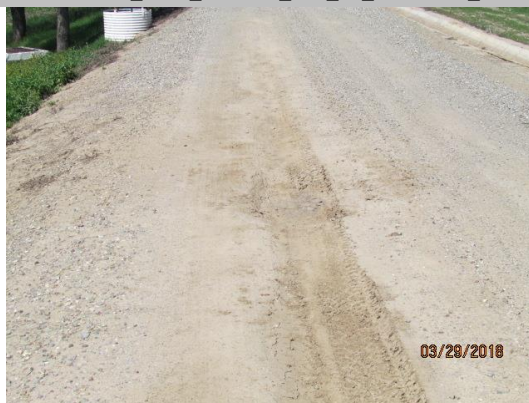
Photo 1 of 1 : SP_2019_RD2092_116_39_20190307_00023.jpg

Looking upstream at rutting and depression on levee crown. (Spring 2018)

| C2 : Repair depressions or ruts in the crown or slope. | | | | | |

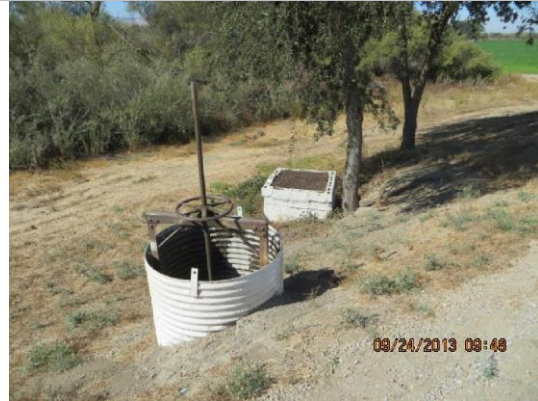
Photo 3 of 3 : UCIP_SP_2019_53820_35213.jpg

| FS_ID:53820 DS_ID:20562 EP_NO: N/A Repair Type: Non-Urgent Crossing Status: Found UCIP Comments: 03/12/2019 During UCIP visual inspection, no pipe or levee integrity issues were observed. Distribution box located on the WS is falling apart (bricks missing). This crossing is an active crossing however, no permit has been found authorizing crossing. Need to determine who maintains and operates this crossing. (O. Magana - DWR UCIP) FIELD_STRUCT_DESC: 36-inch corrugated metal drainage pipe through the levee, 15 feet below the crown. Slide gate in a 48-inch corrugated metal pipe (CMP) riser on the waterside (WS) slope. 4-foot by 6-foot concrete distribution box on the landside (LS) toe. 5-foot by 5-foot concrete riser on the WS toe. [Additional Reference(s): DWR Levee Log, 2005. USACE San Joaquin O&M Manual 5, August 1961, (HLM 1.31)]. FS Date: 3/12/2019 12:06:00 PM | | | | | | |

Slide gate in 48-inch CMP riser on WS slope.

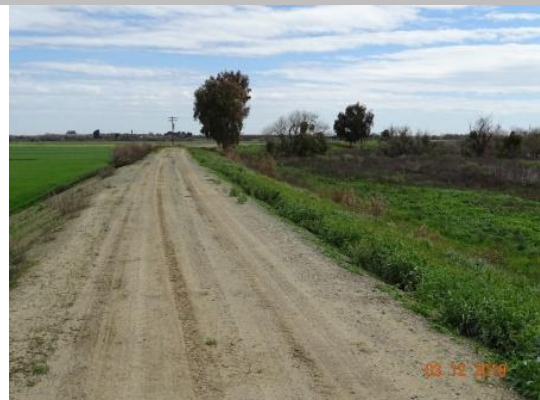
Photo 1 of 2 : SP_2019_RD2092_116_32_20190313_00060.jpg

Control grassy vegetation along waterside slope. (Spring 2019)

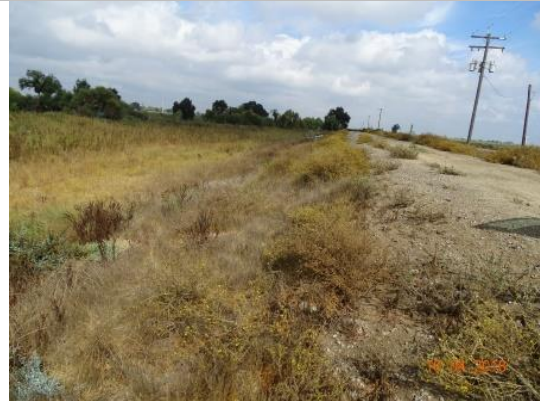
Photo 2 of 2 : SP_2019_RD2092_116_32_20190307_00015.jpg

Vegetation on waterside slope should be maintained. (Fall 2018)

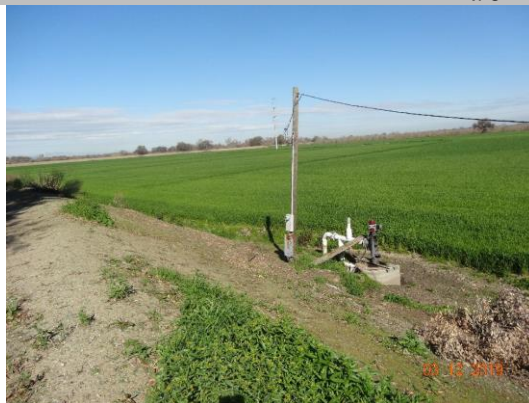
Photo 3 of 3 : UCIP_SP_2019_53814_79093.jpg

| FS_ID:53814 DS_ID:20564 EP_NO: N/A Repair Type: Non-Urgent Crossing Status: Found UCIP Comments: 03/12/2019 Concrete headwall found on LS toe. Pipe appears to have been grouted through. No other appurtenances were found during inspection. WS outlet was not found. Need to coordinate with the CVFPB to determine if additional steps are needed to comply with Title 23. (O. Magana - DWR UCIP) FIELD_STRUCT_DESC: *ABANDONED* 30-inch corrugated metal drainage pipe through the levee, 15 feet below the crown. Flap gate on the waterside (WS) end. Concrete U-shaped headwalls on both ends. Filled with concrete on the landside (LS) toe. [Additional Reference(s): DWR Levee Log, 2005. USACE San Joaquin O&M Manual 5, August 1961, (HLM 2.10), 36-inch pipe listed]. FS Date: 3/12/2019 12:08:00 PM | | | | | | |

LS view: concrete riser, power pole, and groundwater pump station.

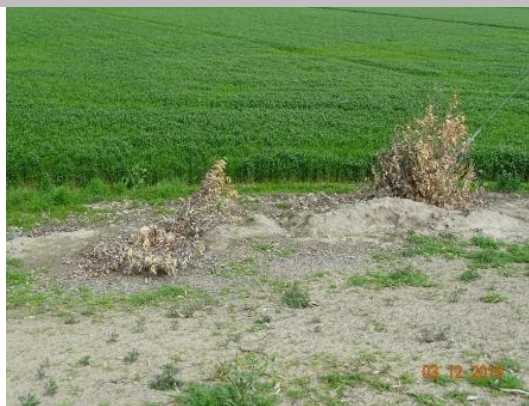
Photo 1 of 2 : SP_2019_RD2092_116_43_20190313_00061.jpg

View of saplings along landside toe. (Spring 2019)

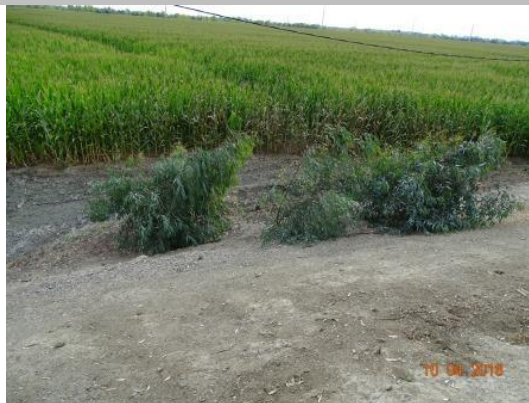
Photo 2 of 2 : SP_2019_RD2092_116_43_20190307_00025.jpg

View of saplings along landside levee toe. (Fall 2018)

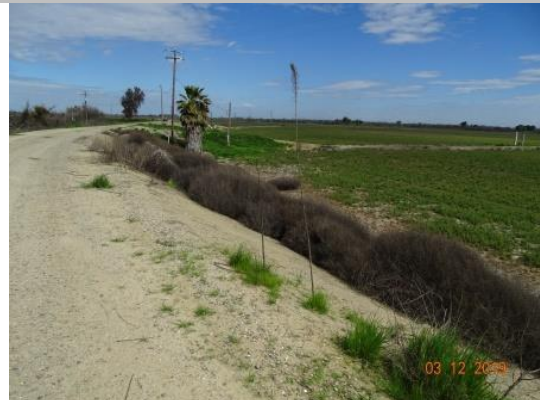
Photo 1 of 2 : SP_2019_RD2092_116_25_20190313_00062.jpg

View of vegetation along landside slope looking downstream. (Spring 2019)

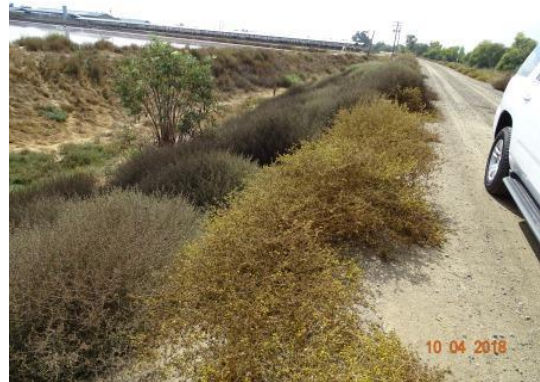
Photo 2 of 2 : SP_2019_RD2092_116_25_20190307_00012.jpg

View of vegetation along landside slope looking upstream. (Fall 2018)

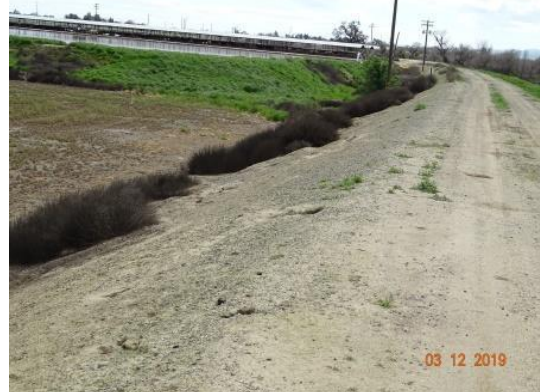
Photo 1 of 1 : SP_2019_RD2092_116_41_20190313_00063.jpg

View of brush along landside slope looking upstream. (Spring 2019)

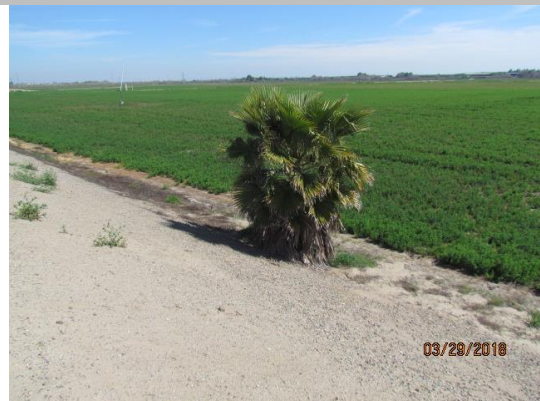
Photo 1 of 1 : SP_2019_RD2092_116_19_20190307_00009.jpg

Looking at Palm tree at landward toe. (Spring 2018)

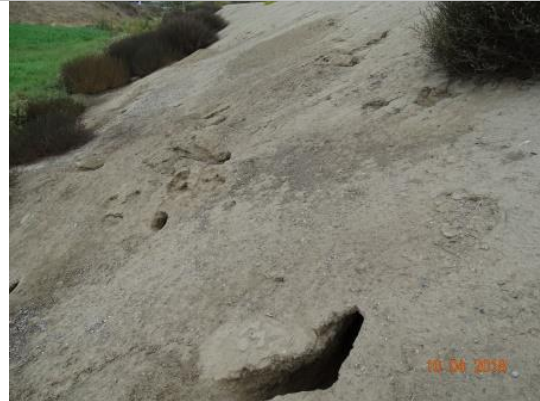
Photo 1 of 1 : SP_2019_RD2092_116_44_20190307_00026.jpg

View of animal burrows looking upstream. (Fall 2018)

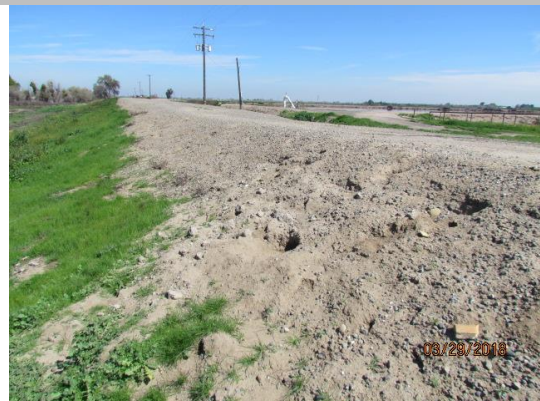
Photo 1 of 4 : SP_2019_RD2092_116_17_20190307_00005.jpg

Looking upstream on waterward slope at several large rodent holes. (Spring 2018)

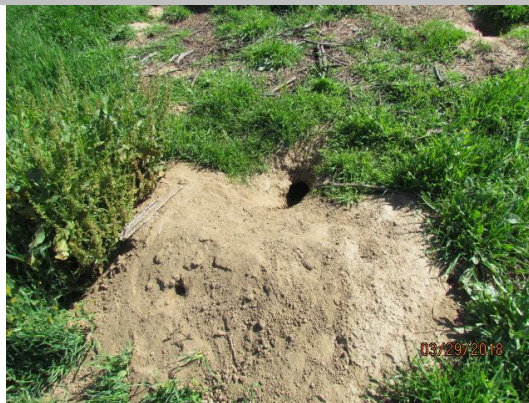
Photo 2 of 4 : SP_2019_RD2092_116_17_20190307_00006.jpg

Looking at typical large rodent holes on waterward slope. (Spring 2018)

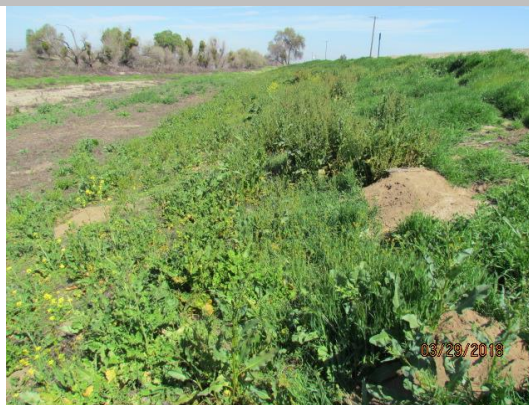
Photo 3 of 4 : SP_2019_RD2092_116_17_20190307_00007.jpg

Looking upstream at large rodent holes on waterward slope. (Spring 2018)

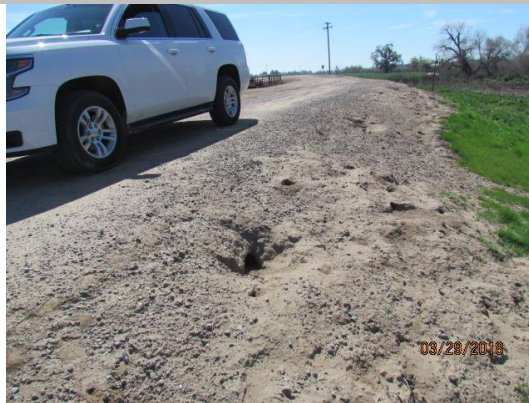
Photo 4 of 4 : SP_2019_RD2092_116_17_20190307_00008.jpg

Looking downstream at several rodent holes on waterward slope. (Spring 2018)

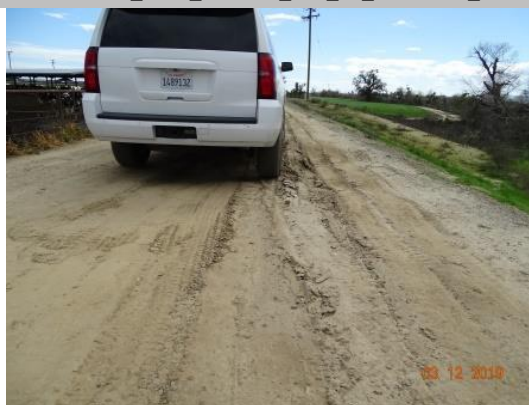
Photo 1 of 2 : SP_2019_RD2092_116_45_20190313_00069.jpg

View of rutting along levee crown. (Spring 2019)

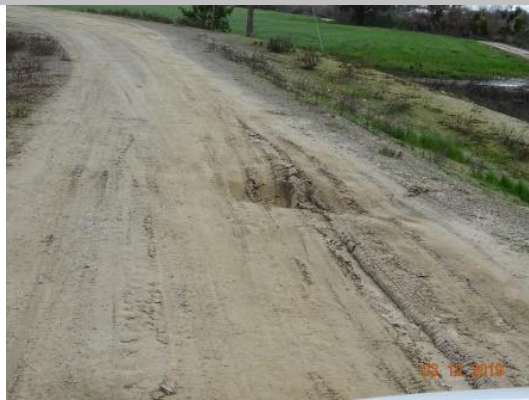
Photo 2 of 2 : SP_2019_RD2092_116_45_20190313_00070.jpg

View of depression in levee crown. (Spring 2019)

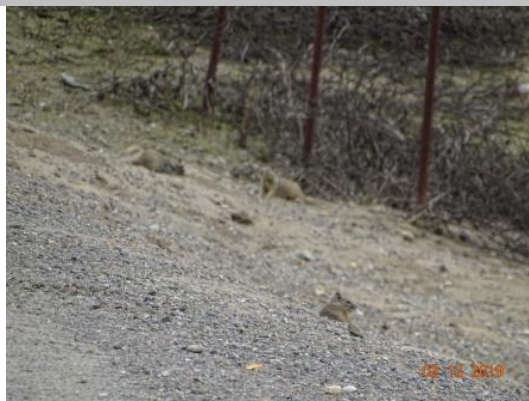
Photo 1 of 3 : SP_2019_RD2092_116_35_20190313_00064.jpg

Squirrels observed along waterside slope. (Spring 2019)

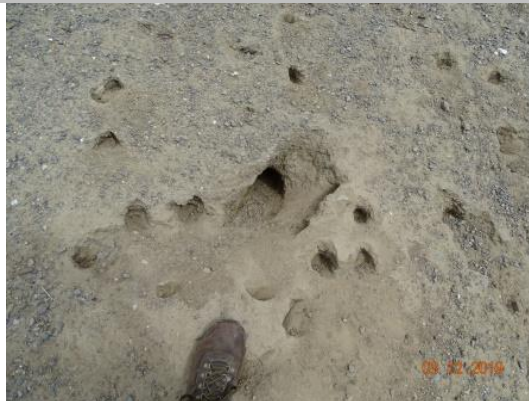
Photo 2 of 3 : SP_2019_RD2092_116_35_20190313_00065.jpg

View of typical rodent holes. (Spring 2019)

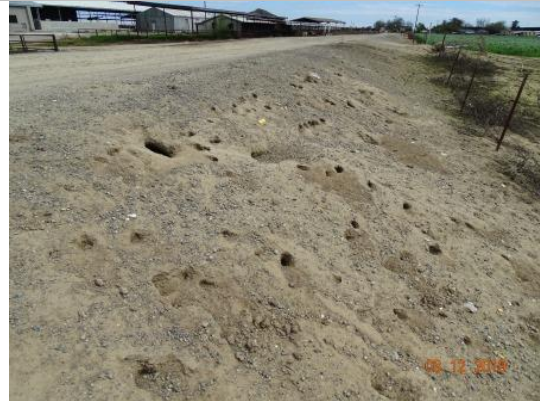
Photo 3 of 3 : SP_2019_RD2092_116_35_20190313_00066.jpg

View of several rodent burrows along waterside slope. (Spring 2019)

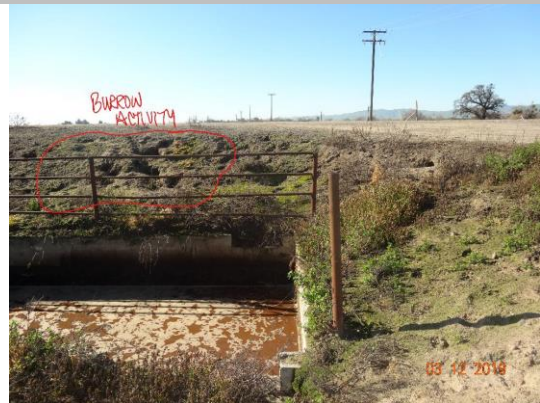
Photo 3 of 3 : UCIP_SP_2019_53810_79140.jpg

LS view: heavy burrow activity observed on LS slope.

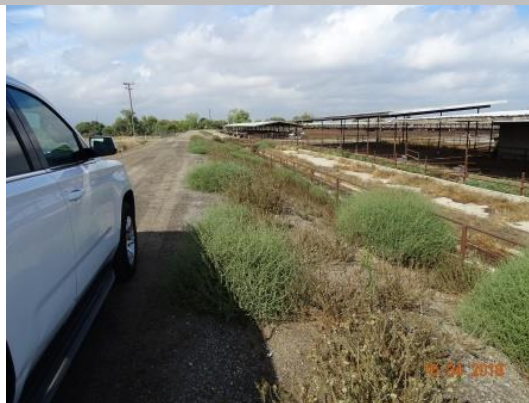
Photo 1 of 1 : SP_2019_RD2092_116_16_20190307_00004.jpg

Vegetation along landside slope. (Fall 2018)
